UNITED STATES ENVIRONMENTAL PROTECTION AGENCY

Memorandum

Subject: Field Inspection Former Plainwell Impoundment, Dec. 3, 2012

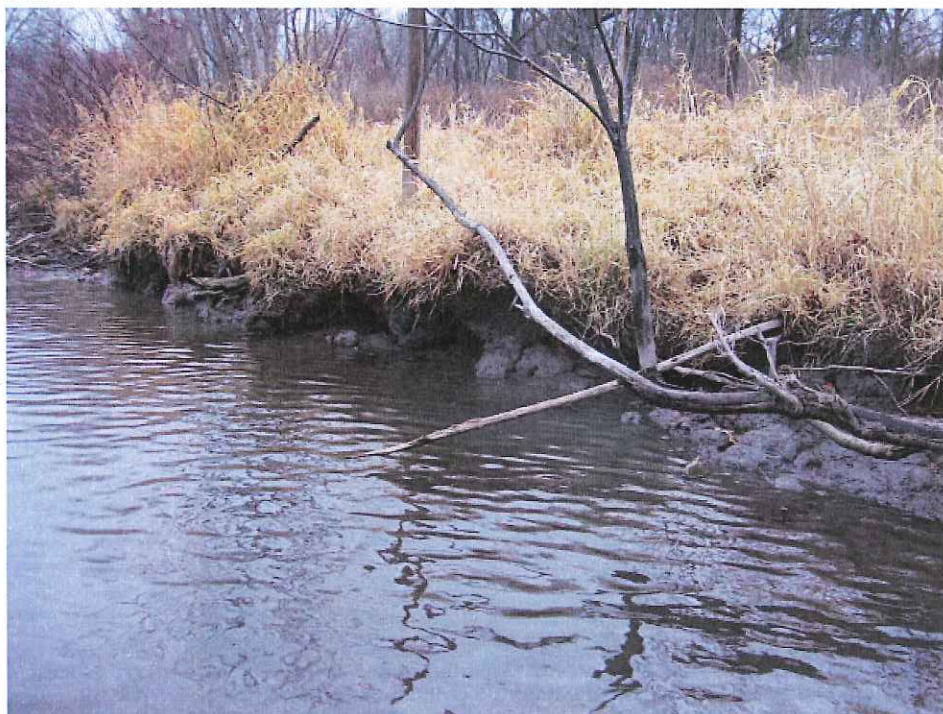
1. Approximate Location: Bank area RA 2A east (south) end.
Lat 42.45002 Long -85.65005. The bank is severely eroded with contaminated residuals exposed. (See Photo 1 Enclosure). Continued erosion in this area has the potential to expose additional contaminated residuals.

Photo 1, Approximate location RA 2A east end. Bank is severely eroded with contaminated residuals exposed. (Mendoza, 12/3/12).

Requested Repair: Cover the exposed area with geotextile fabric and rocks using the conceptual design for RA Area 4A as described in the Bank Repair Plan Technical Memorandum Revised November 2012 (Dated November 15, 2012).

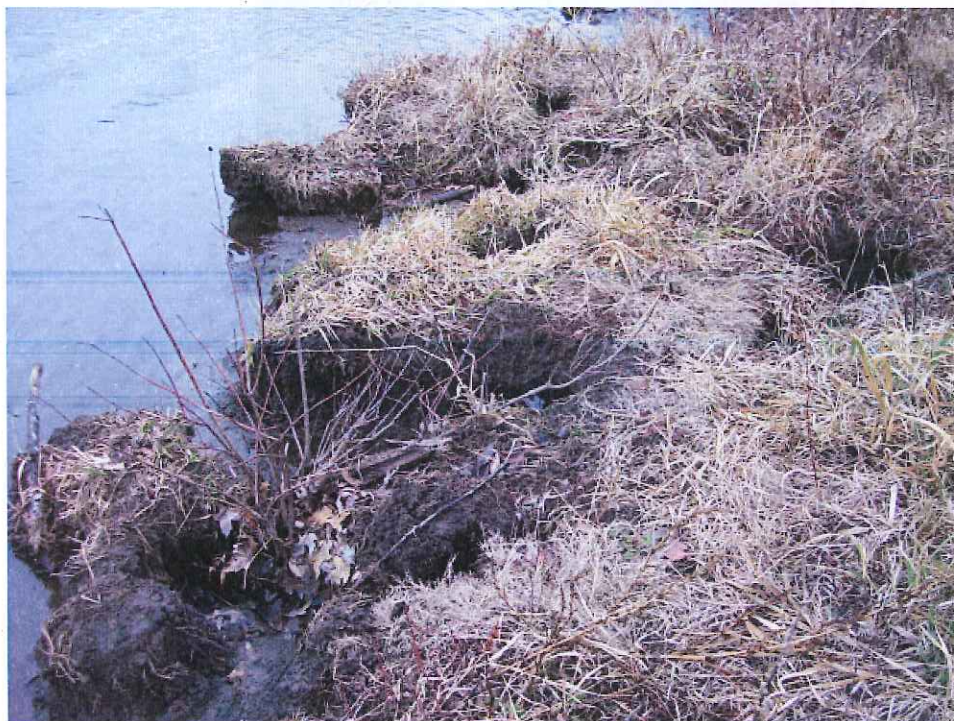
2. Approximate Location: West end (north) of RA 4A to start of RA 5. Lat 42.45406 Long -85.65257. The area shows signs of erosion (See Photo 2 Enclosure). Continued erosion in this area has the potential to expose contaminated residuals.

Photo 2, Approximate location: West end of RA 4A. Severely eroded bank. (Mendoza, 12/3/12)

Requested Repair: Extend the current downstream boundary of repairs in RA 4A to the bend up to the border of Removal Area 5A, using the same conceptual design in the November 15, 2012 Bank Repair Plan.

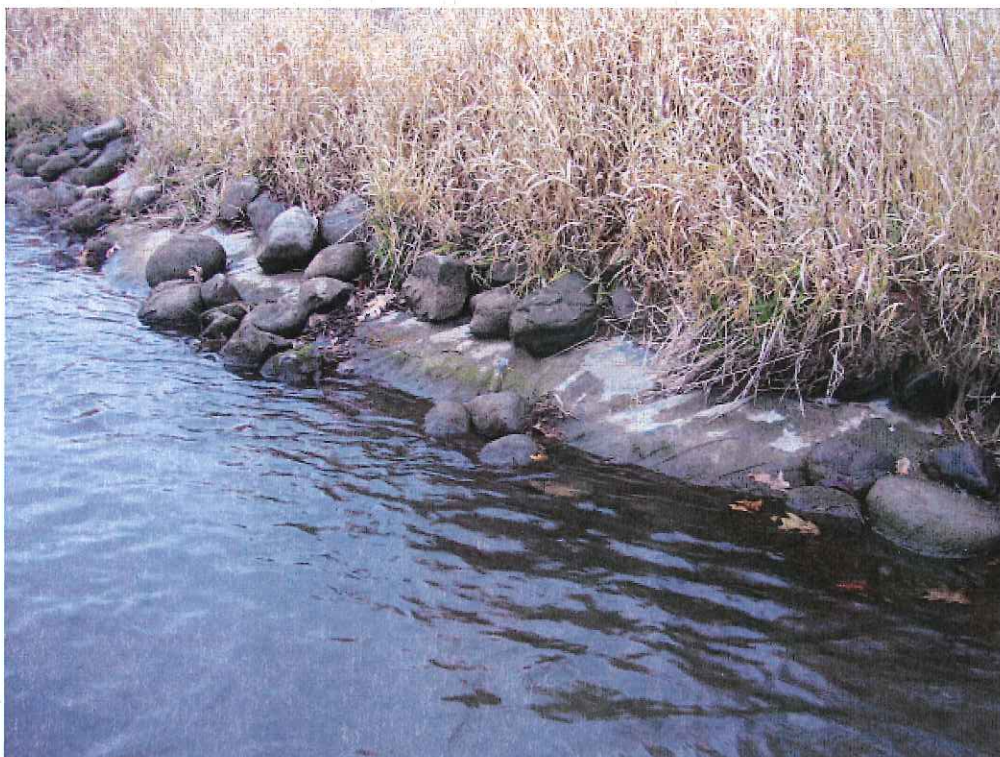
3. EPA and MDEQ observed the following areas where the rock armoring has fallen off the bank exposing the geotextile fabric beneath. We request that these areas be repaired by replacing the rock to avoid bank failure:

Photo 3, Approximate location, Removal Area 3A. Exposed geotextile (Mendoza, 12/3/2012)

- a) Approximate Location: Removal Area 3A, Lat 42.45127 Long -85.65054 (see Photo 3 Enclosure)
- b) Approximate Location: Removal Area 4B, Lat 42.45181 Long -85.65208 about 20 feet upstream of the open area where we off loaded our boats (See Photo 4, Enclosure)
- c) Approximate Location: Removal Area 9A, Lat 42.45505 Long -85.66090
- d) Approximate Location: Removal Area 9A approximately 200 feet upstream of: Lat 42.45505 Long -85.66090.
- e) Approximate Location: Western Channel Area, upstream of planned repair area. Lat 42.5521 Long -85.66835. (See Photo 5, Enclosure.)

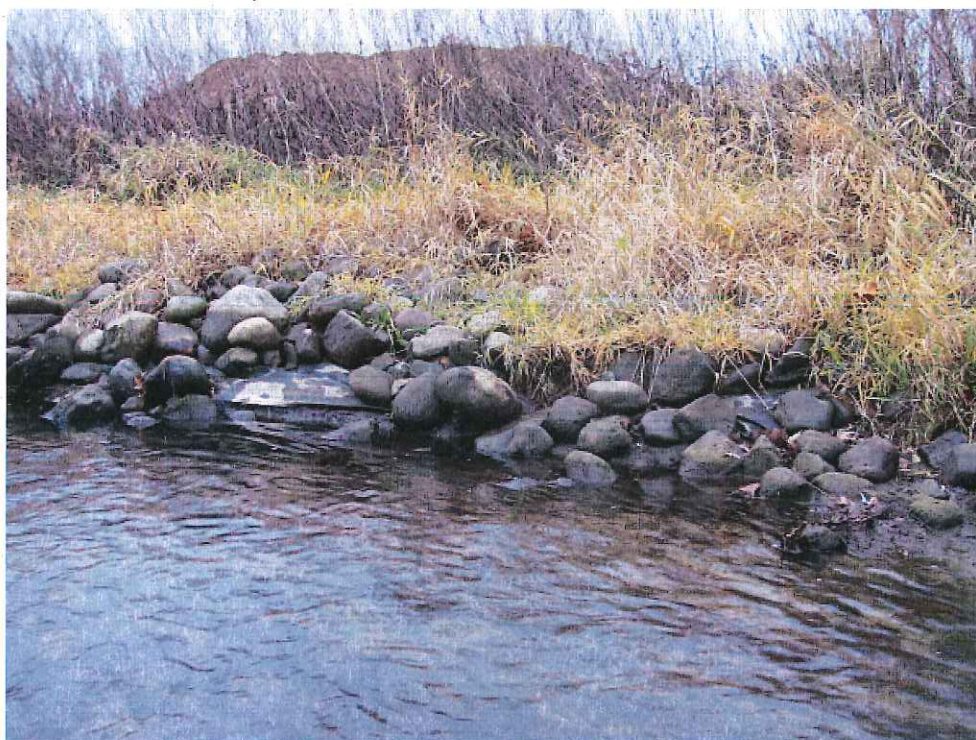
Photo 4, Approximate location, Removal Area 4B Exposed geotextile (Mendoza, 12/3/12)

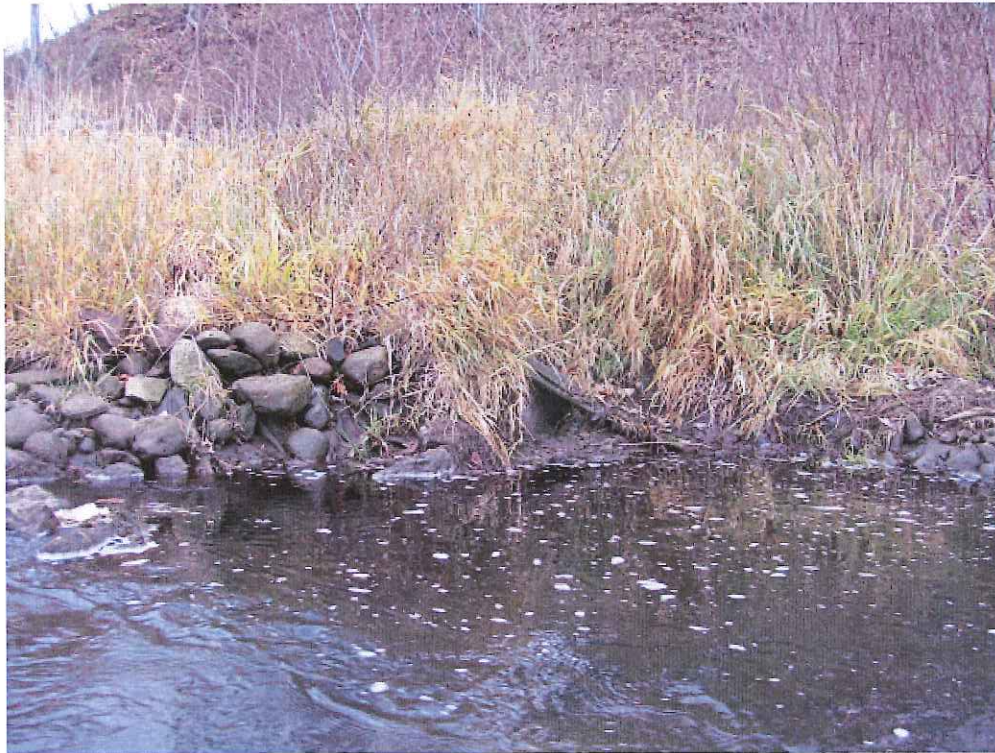
Photo 5, Approximate location, Western Channel Area, upstream of the planned repair area. (Mendoza, 12/3/12)

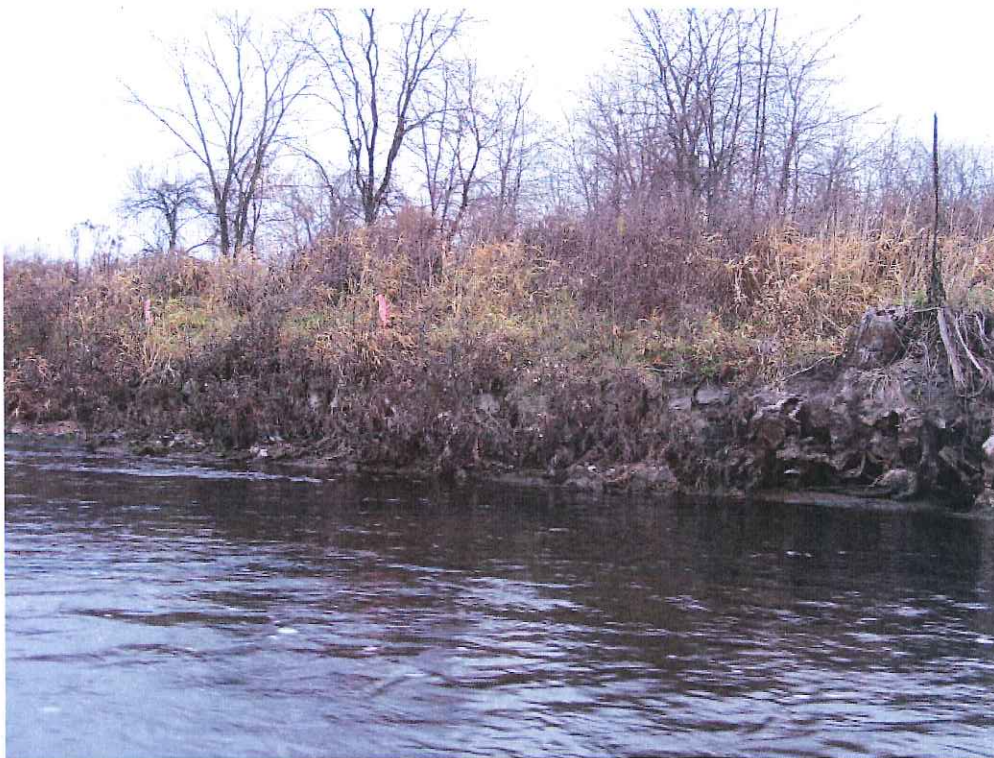
The representatives also visited the eroded bank in Removal Area 10A, Pipeline Crossing (see photos 6 & 7 Enclosure). U.S. EPA continues to request that the exposed waste and bank in this area be sampled and analyzed to determine the level of PCBs present. I request another meeting to discuss this issue as soon as possible.

Photo 6, Removal Area 10A showing the eroded bank with exposed contaminated material. (Mendoza, 12/3/12)

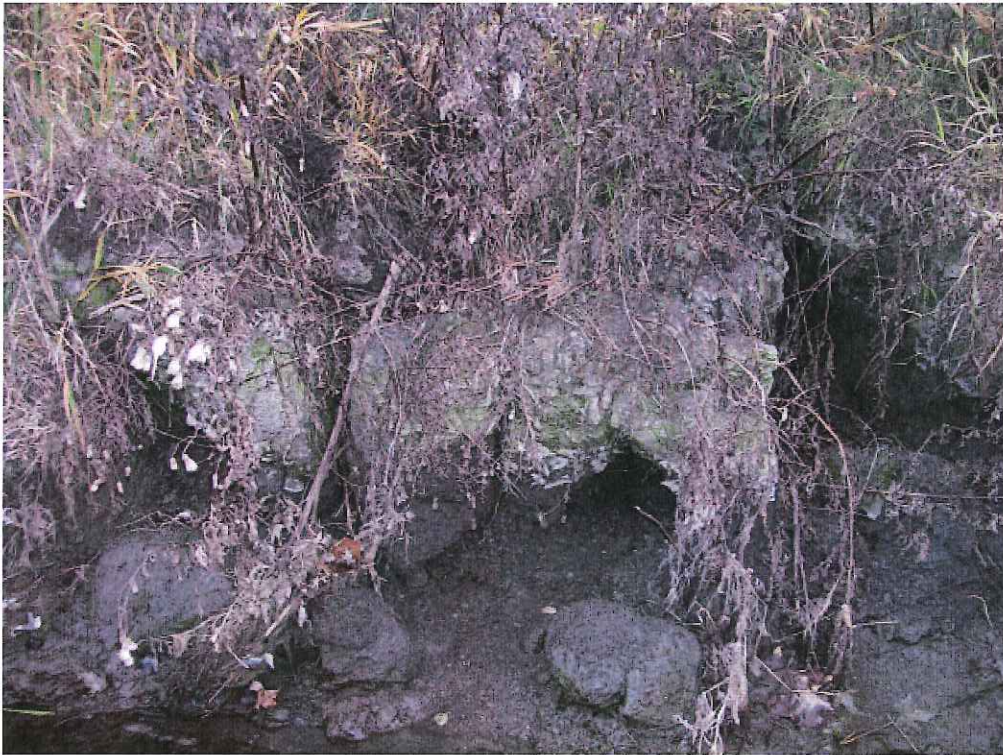
Photo 7, Removal Area 10 A closeup of eroded bank and exposed contaminated material (Mendoza, 12/3/12).
